Situation Photo Log

Thursday, September 13, 2012

Kalamazoo River / Enbridge Spill

Prepared by:
Matthew Haak
START-USEPA
Situation Unit Leader

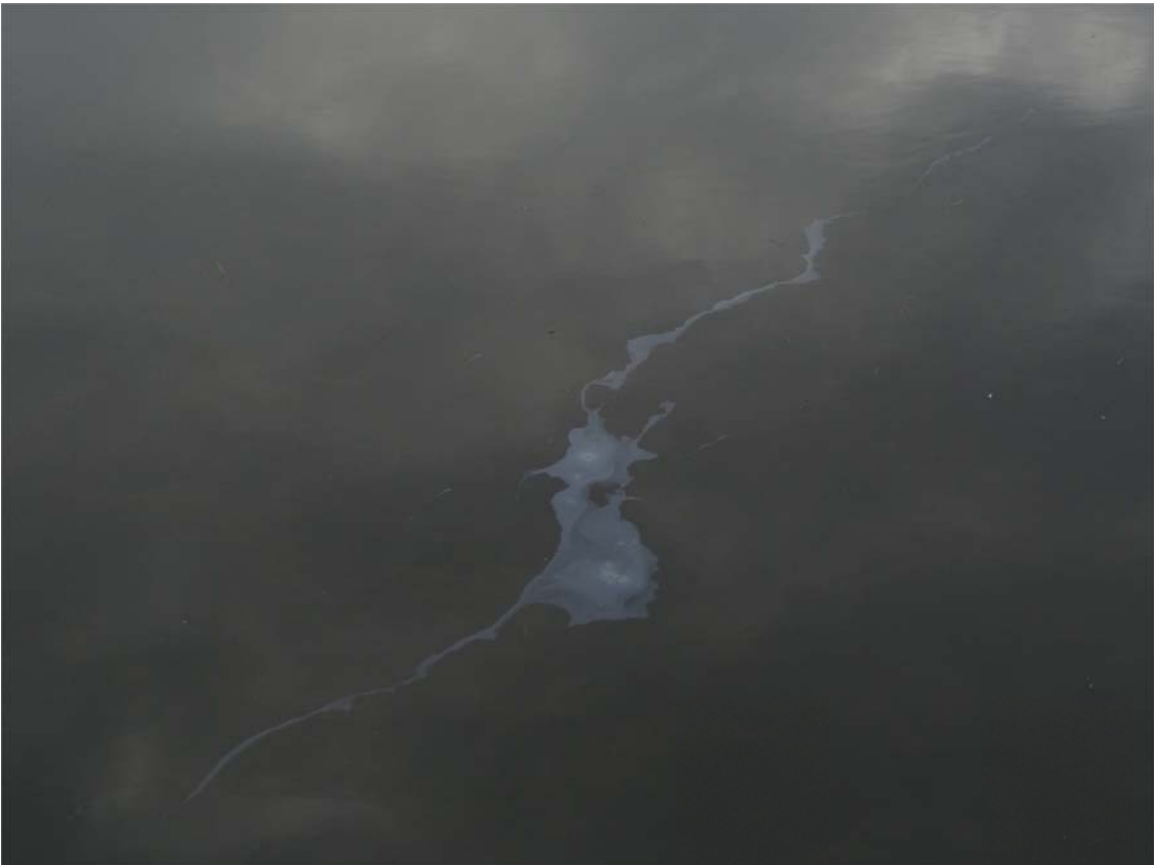
24. MP4.5 LDB sheen observed.

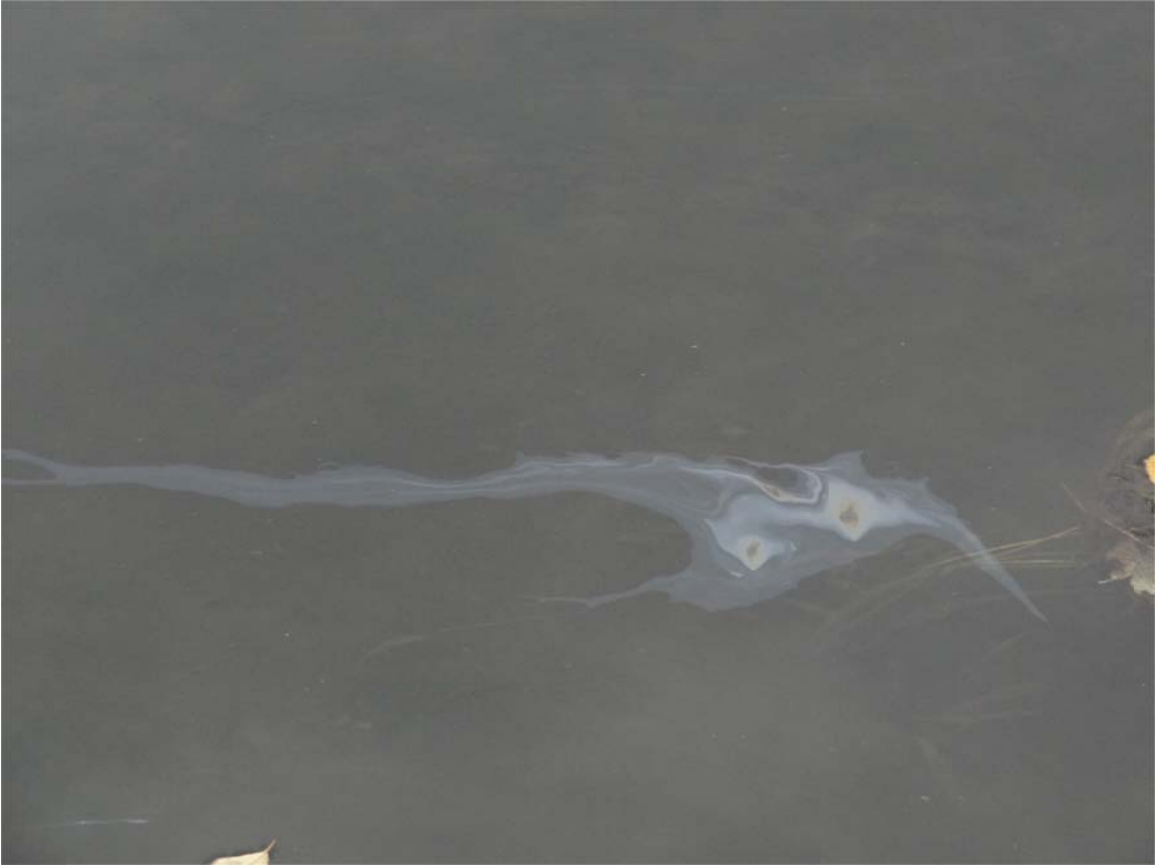
25. MP4.5 LDB sheen observed.

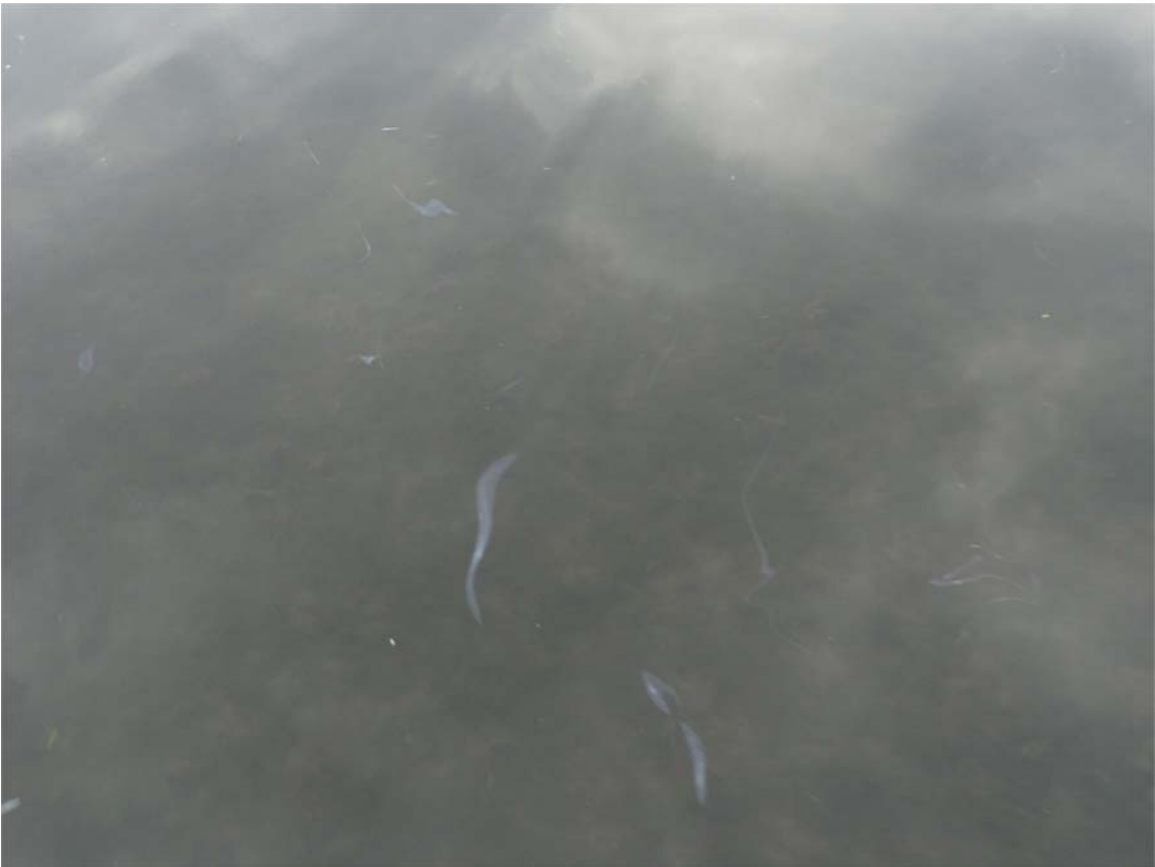
26. MP4.5 LDB sheen observed.

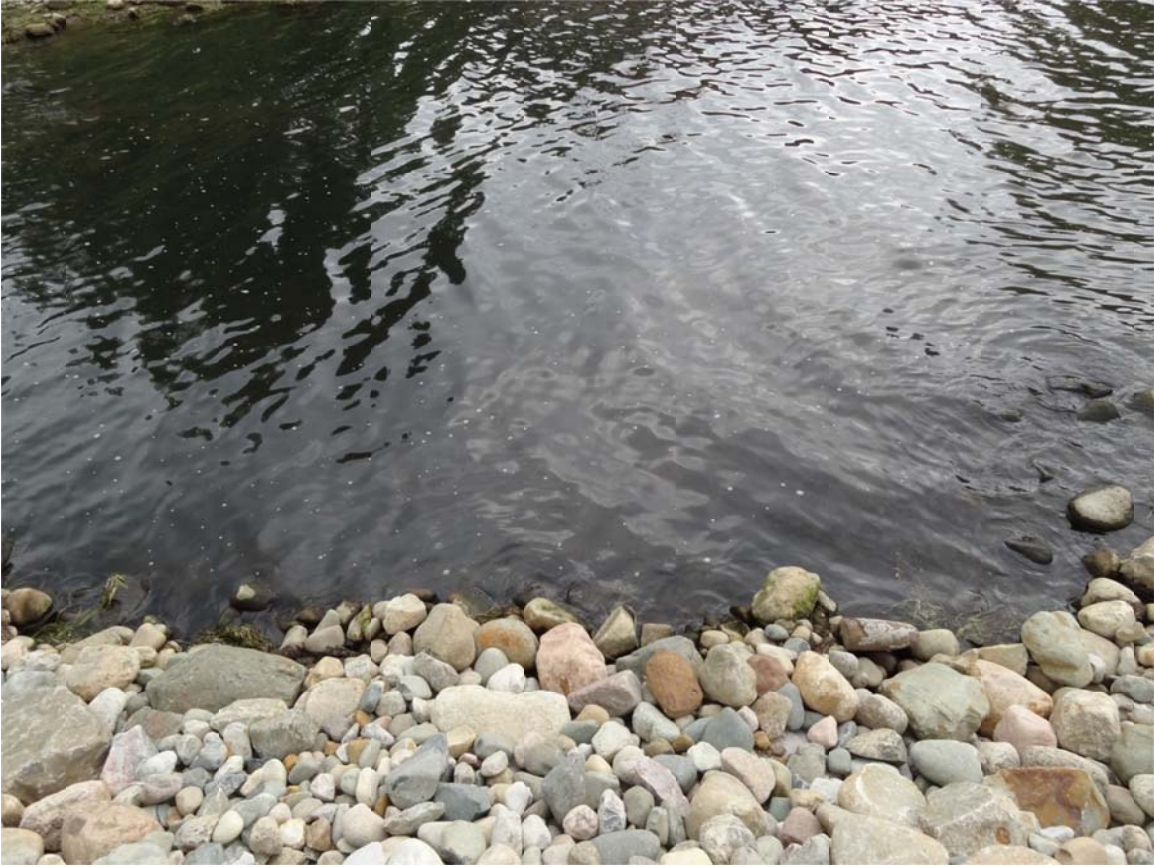
27. Portage below Ceresco Dam sheen observed.

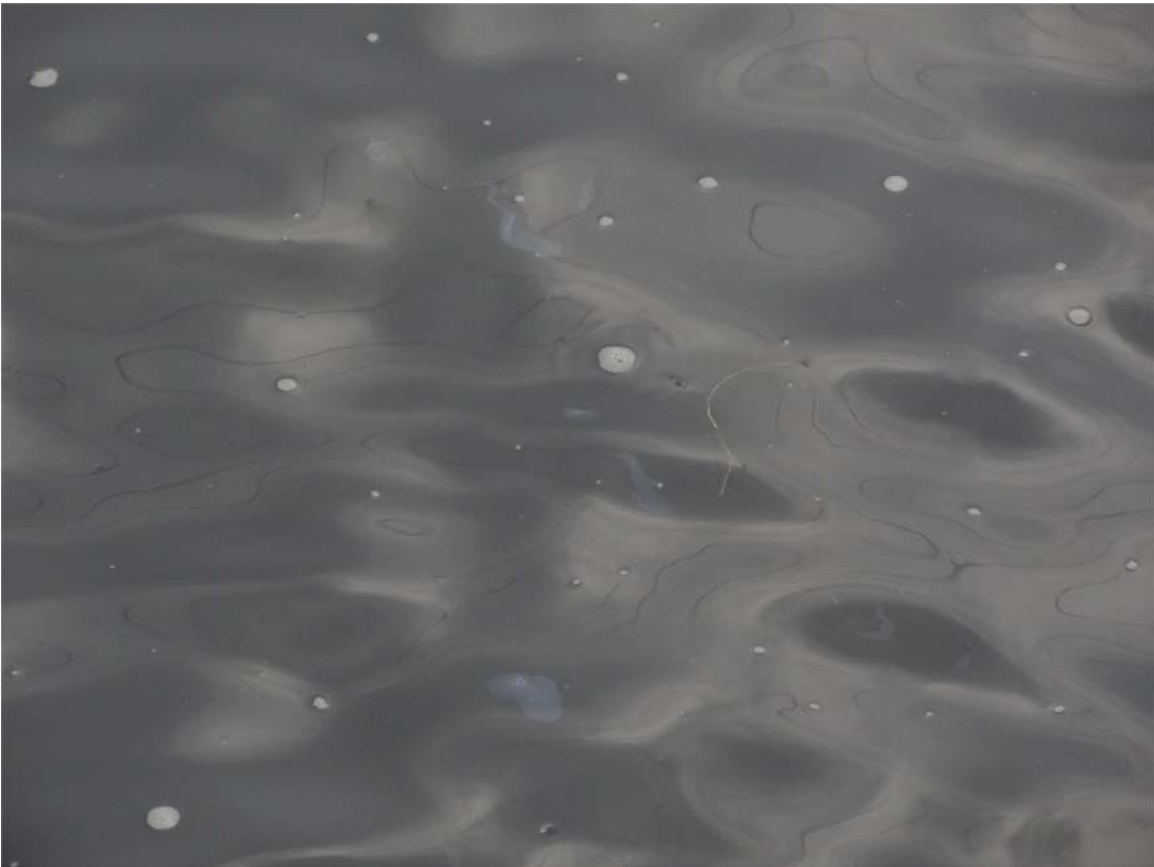
28. Portage below Ceresco Dam sheen observed.

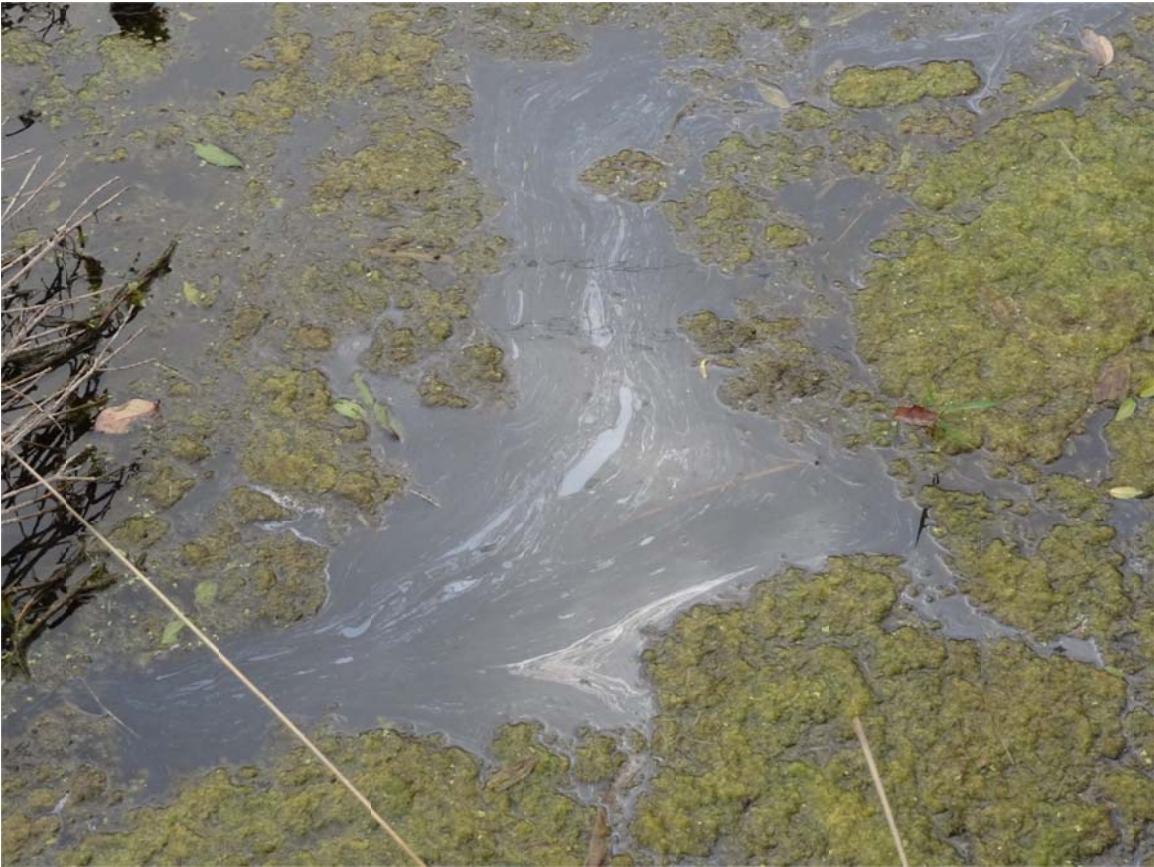
31. MP10.75 sediment trap sheen observed.

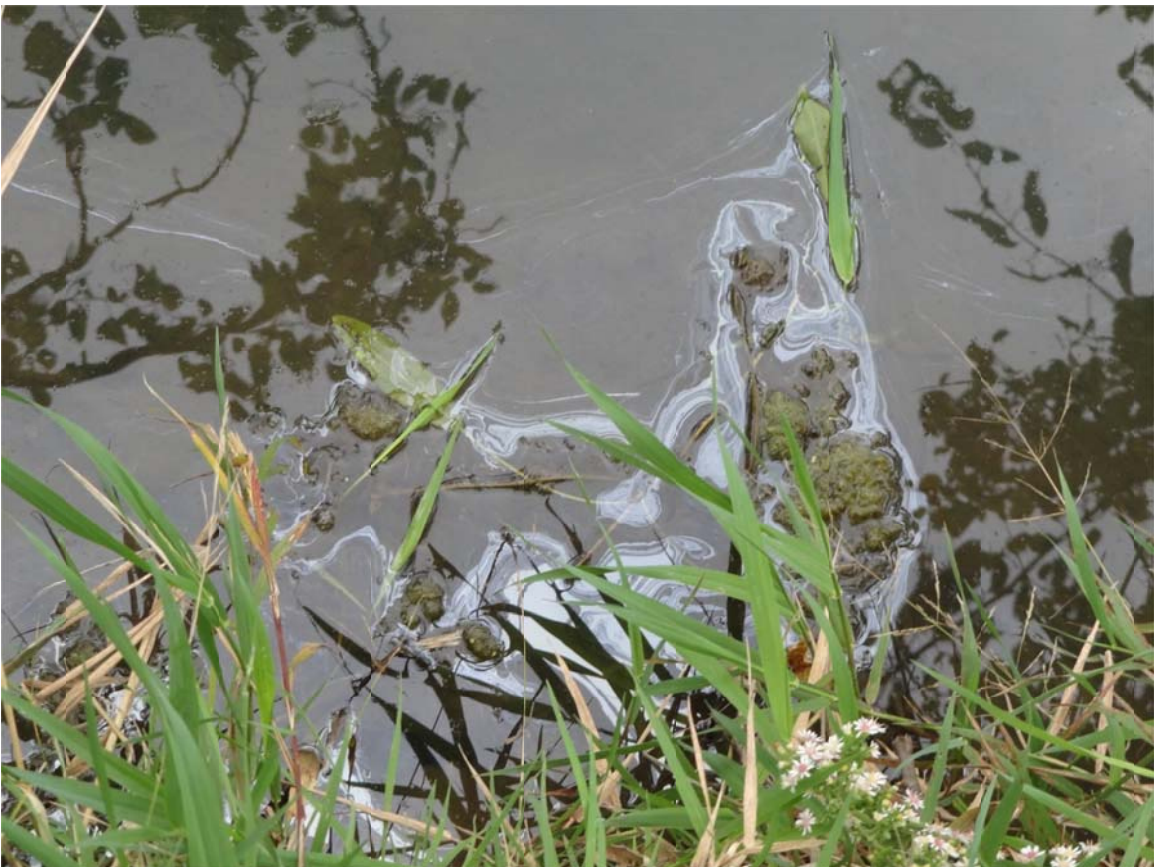
32. MP10.75 sediment trap sheen observed.

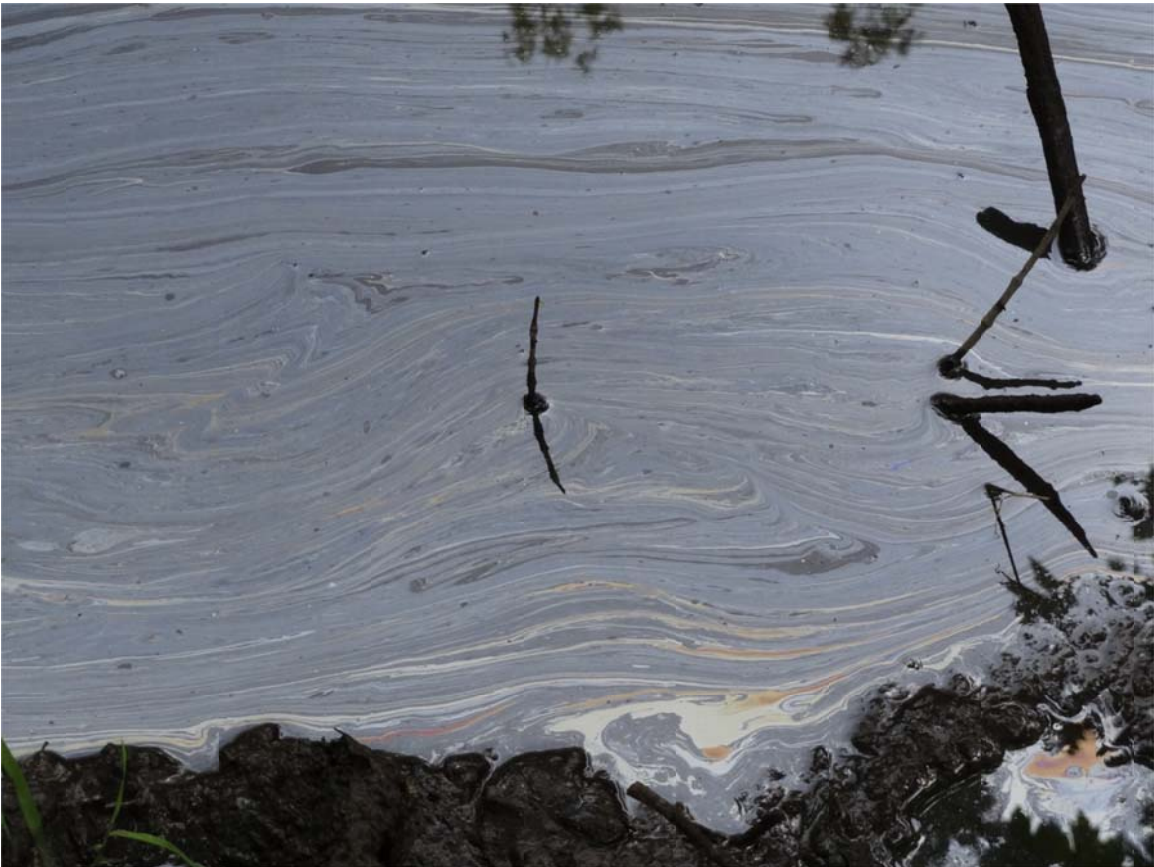
34. MP11.78 back channel sheen observed where the Bathymetry team was operating.

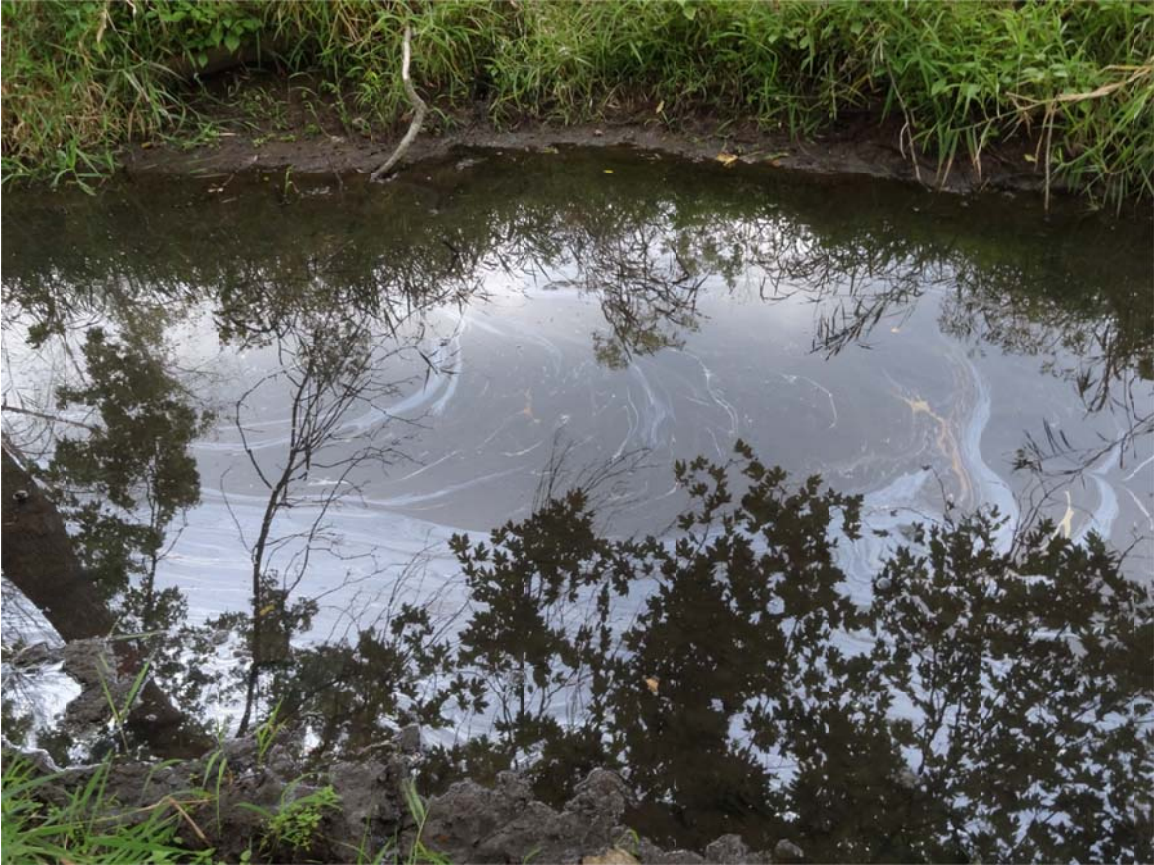
35. MP11.78 back channel sheen observed where the Bathymetry team was operating.

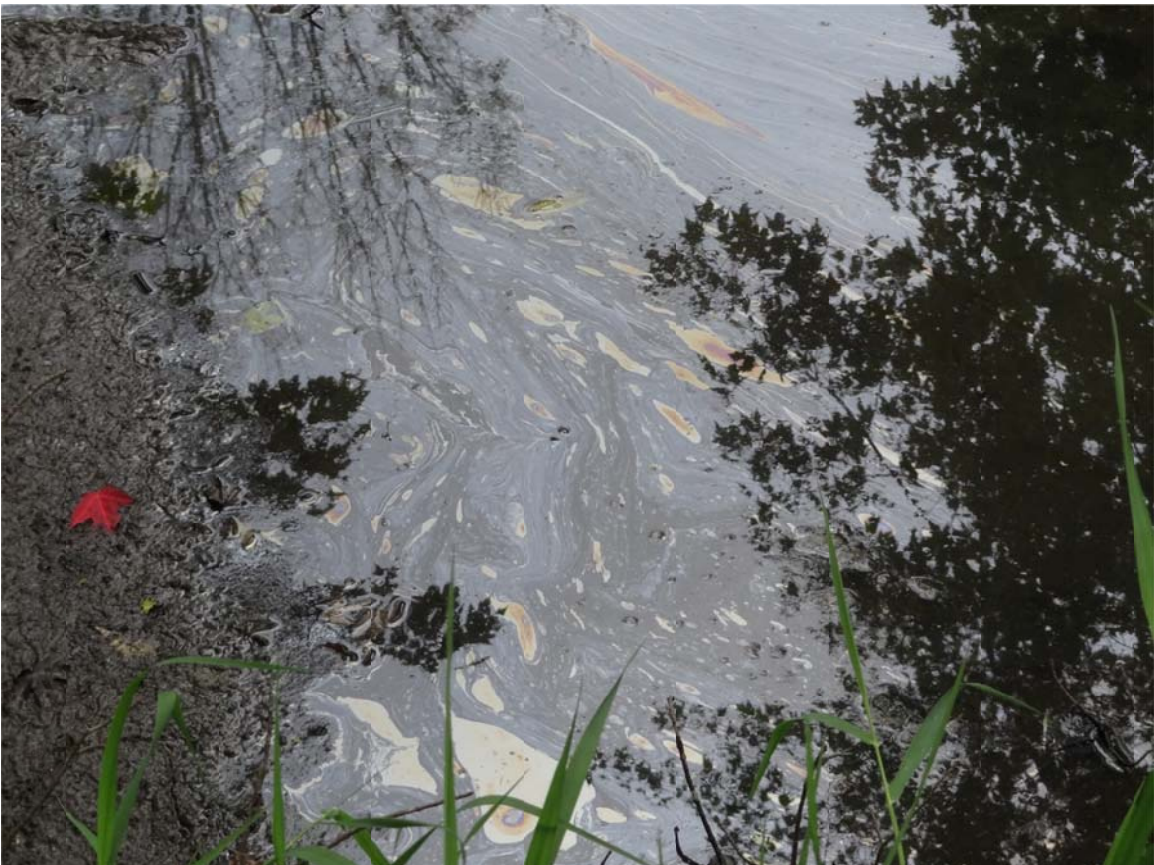
36. MP11.78 back channel sheen observed where the Bathymetry team was operating.

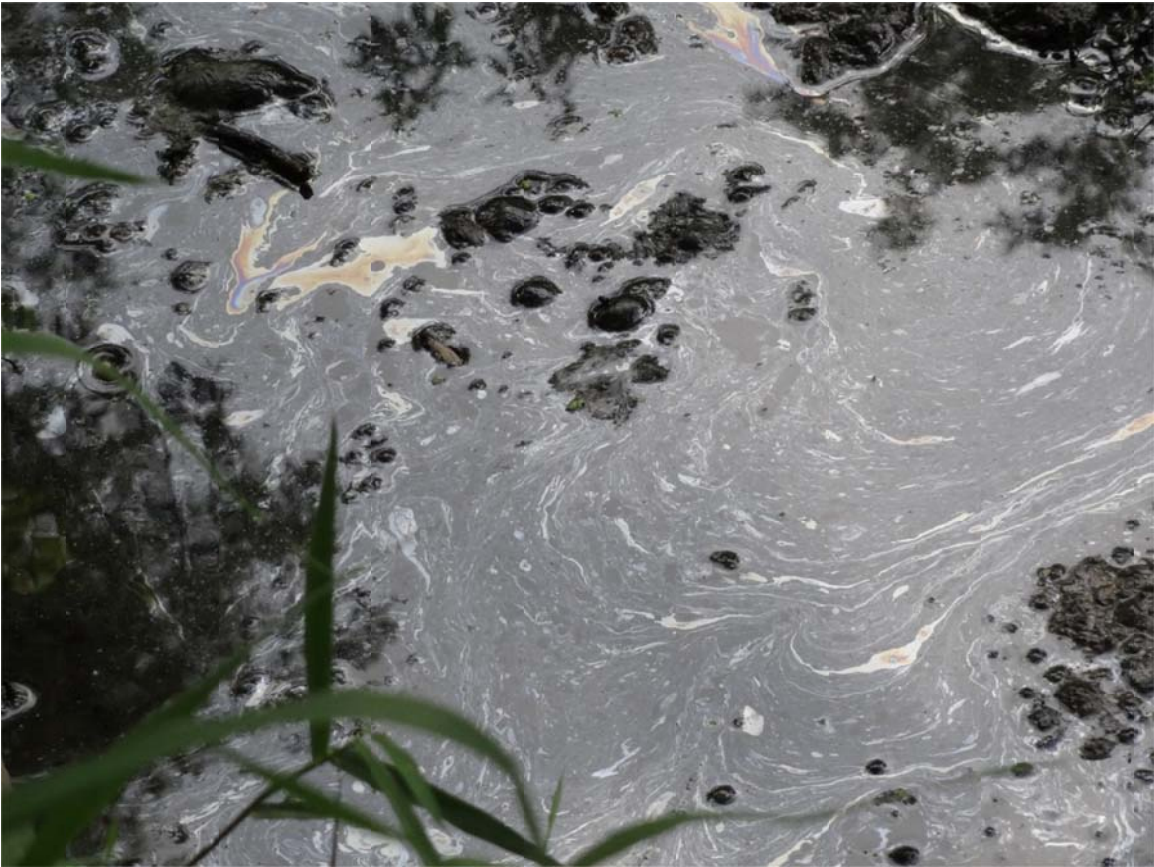
37. MP11.78 back channel sheen observed where the Bathymetry team was operating.

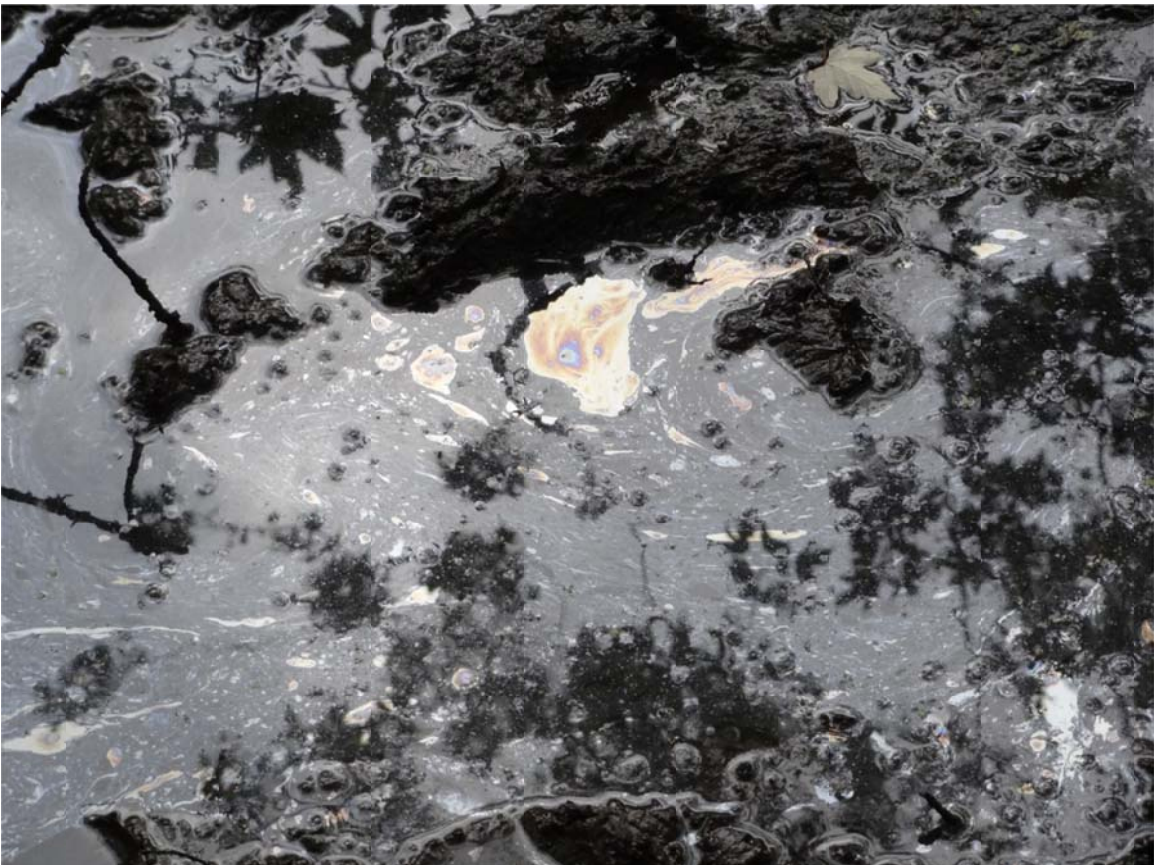
38. MP11.78 back channel sheen observed where the Bathymetry team was operating.
